PERFORMANCE OF AN ENERTECH 44 DURING 11 YEARS OF OPERATION

R. N. Clark and R. G. Davis
USDA-Agricultural Research Service
Conservation and Production Research Laboratory
Bushland, TX

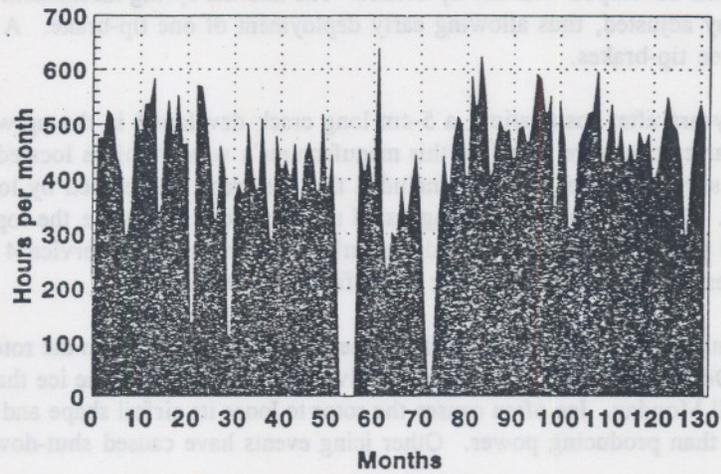
FIGURE 1. MONTHLY HOURS OF ACTUAL ON-LINE TURBINE OPERATION.

The annual average wind speed during the 11 years was 5.71 m/s measured at the 10-m height. The wind speed at hub height (25 m) was calculated to average 7.1 m/s, about 25% higher. The total run hours for each month are presented in Figure 1. During the 132 months reported by these data, the turbine was in operation for 125 complete months. The four dips in this curve show the time the turbine was removed from the tower, either to replace the generator with a different size, or to repair the tower. These replacement or repair dates are listed in Table 1. The other dips in the curve can be identified with significant off-times as listed in Table 3. It is interesting to note that the 60 kW ran fewer hours, months 29 to 71, than either the 25 or 40 kW units. The wind turbine averaged running about 5400 hours per year or 61% of the time. Total number of hours in operation during the 11 years was 55,716 hours.

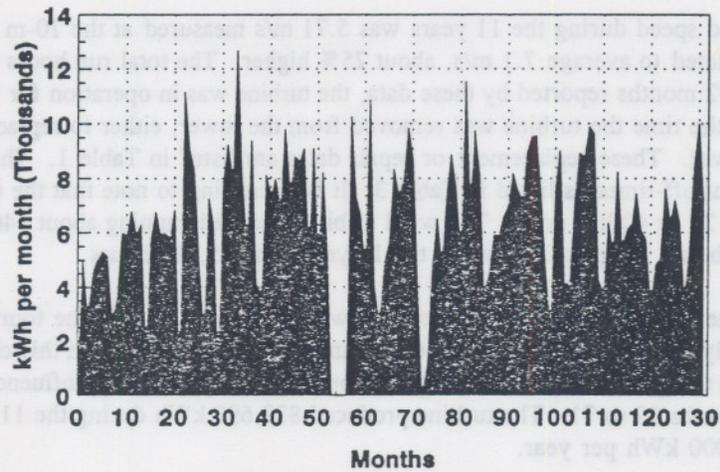
FIGURE 2. MONTHLY ENERGY (kWh) PRODUCED BY THE WIND TURBINE.

The monthly energy generated by the wind turbine is shown in Figure 2. Again the four times the turbine was removed from the tower are clearly shown; however, other down-times show their impact in this chart. During the period 1 to 20 months, the results from using the smaller 25 kW generator is seen; however, the influence of the 60 kW generator is not clearly shown during months 29 to 71. The turbine produced 839,699 kWh during the 11 years and averaged 6,700 kWh per month or about 80,000 kWh per year.

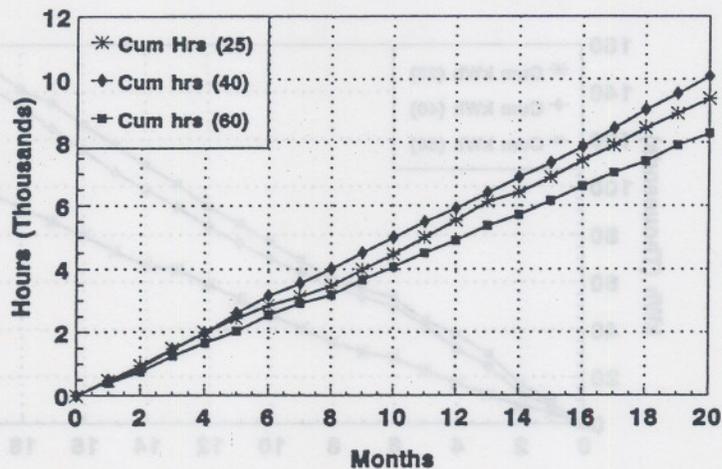
FIGURE 3. CUMULATIVE MONTHLY RUN-HOURS FOR 20 CONSECUTIVE MONTHS FOR EACH SIZE GENERATOR.

As a comparison of the three generator configurations studied during the operation of this wind turbine, 20 months of similar data were selected for each generator type and the energy production and hours of operation were compared. The cumulative hours for 20 continuous months of operation for the three generator configurations are shown in Figure 3.

Notice that the 40 kW generator ran more total hours than either the 25 or 60 kW. When comparing the energy produced (Figure 4), the 40 and 60 kW generators clearly out produced the 25 kW, but the differences between the 40 and 60 kW were not significant. Since these data were collected at different times and the average wind speed were not exactly the same, the differences could have been reduced because of wind speed. However, all data presented show that the 60 kW generator does not exhibit a clear advantage over the 40 kW. Actually, an optimum generator for this 13.4-m rotor may be 50 kW rather than the 40 or 60 kW studied (Vosper and Clark, 1985b).

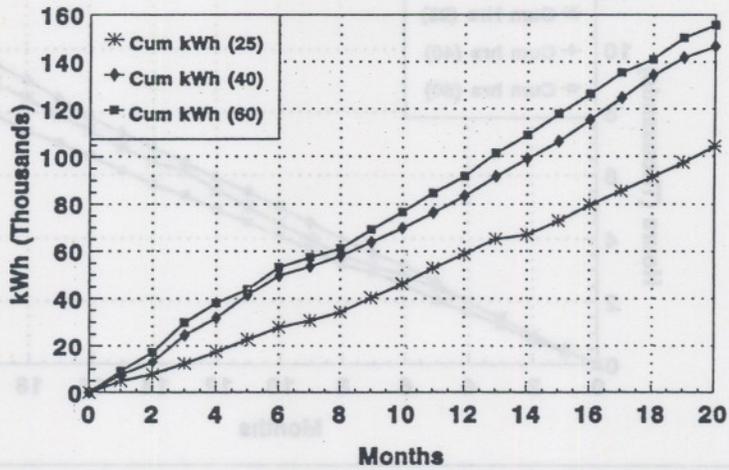
FIGURE 4. CUMULATIVE MONTHLY ENERGY (kWh) PRODUCED FOR 20 CONSECUTIVE MONTHS FOR EACH SIZE GENERATOR.

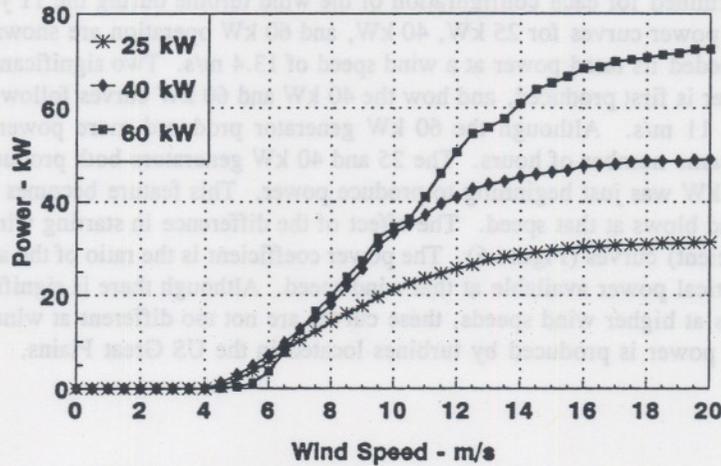
FIGURE 5. MEASURED POWER CURVES FOR EACH GENERATOR TESTED. THE POWER WAS CORRECTED TO STANDARD DENSITY AND THE WIND SPEED WAS MEASURED AT 25-m, HUB HEIGHT.

Power curves were determined for each configuration of the wind turbine during the 11 years using measured hub-height wind speeds. The three power curves for 25 kW, 40 kW, and 60 kW operation are shown in Figure 5. In each case, the machine reached or exceeded its rated power at a wind speed of 13.4 m/s. Two significant features of these power curves are the point where power is first produced, and how the 40 kW and 60 kW curves follow closely until they diverge when the wind speed exceeds 11 m/s. Although the 60 kW generator produced more power at high wind speeds, it didn't necessarily operate the same number of hours. The 25 and 40 kW generators both produced about 5 kW at a wind speed of 5.5 m/s while the 60 kW was just beginning to produce power. This feature becomes significant because of the large number of hours the wind blows at that speed. The effect of the difference in starting wind speed is clearly shown by the efficiency (power coefficient) curves (Figure 6). The power coefficient is the ratio of the actual power produced at a given wind speed to the theoretical power available at that wind speed. Although there is significant differences between the 40 and 60 kW power curves at higher wind speeds, these curves are not too different at wind speeds between 7 and 11 m/s; where most of the wind power is produced by turbines located in the US Great Plains.

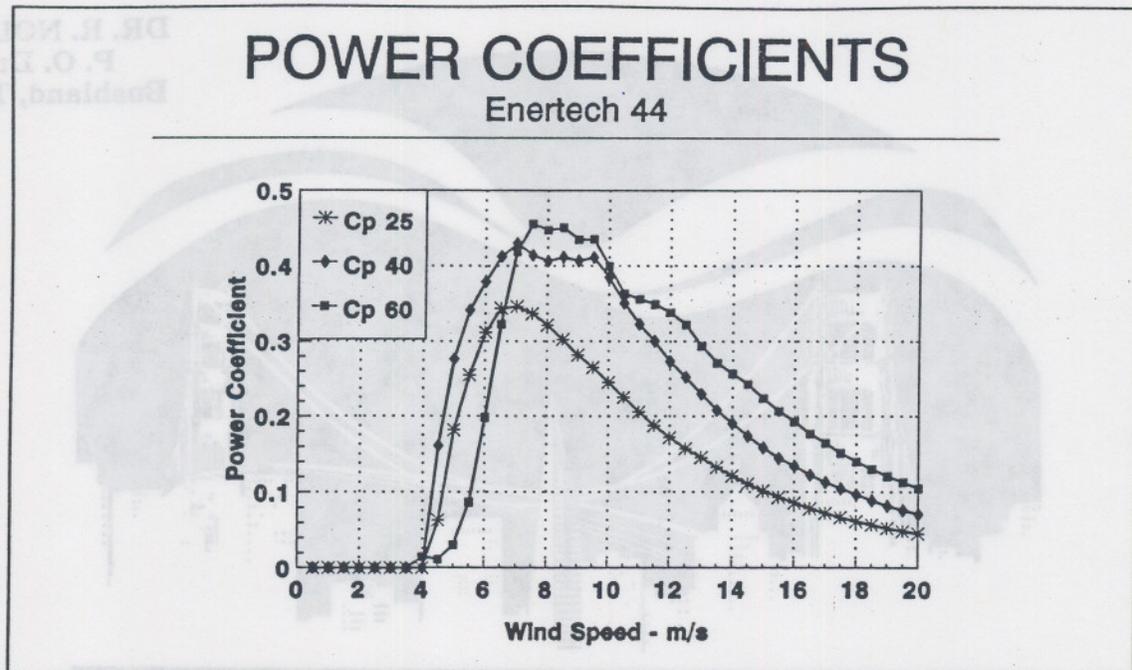
FIGURE 6. THE POWER COEFFICIENT OF THE WIND ELECTRIC GENERATORS AS DETERMINED BY THE RATIO OF ACTUAL POWER TO THEORETICAL POWER.
